Kenwood TS-2000 receiver crackling noise problem

Ceramic filter failure – how to change the filters

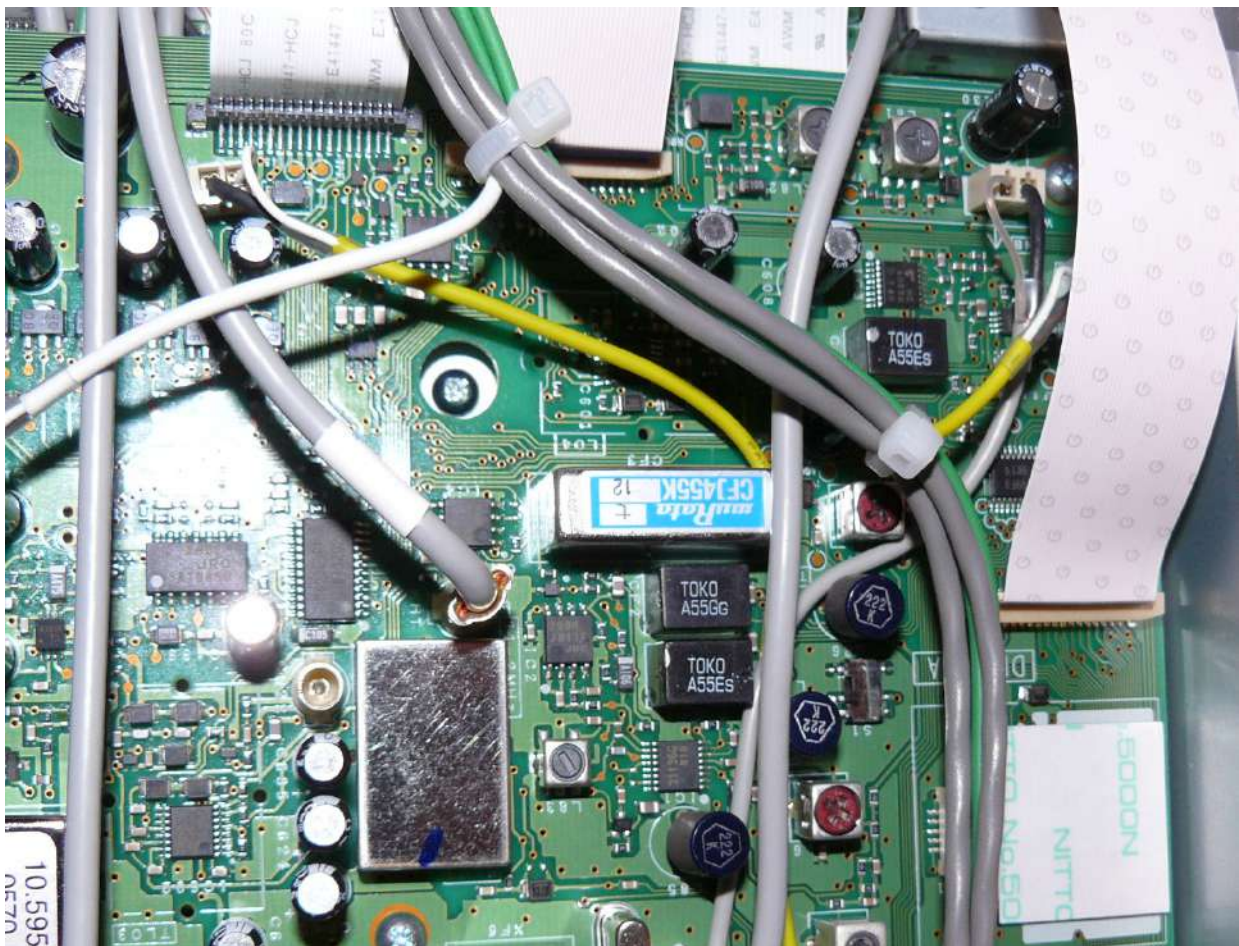
The MAIN receiver filters are located on the TX/RX board in the bottom (underside) of the radio. The board are marked right next to the filters, CF1, CF2, CF3 (Murata CFJ455K 12) and CF4. The Murata 2.7kHz ceramic filter (CF3) is a different construction and does not need to be replaced.

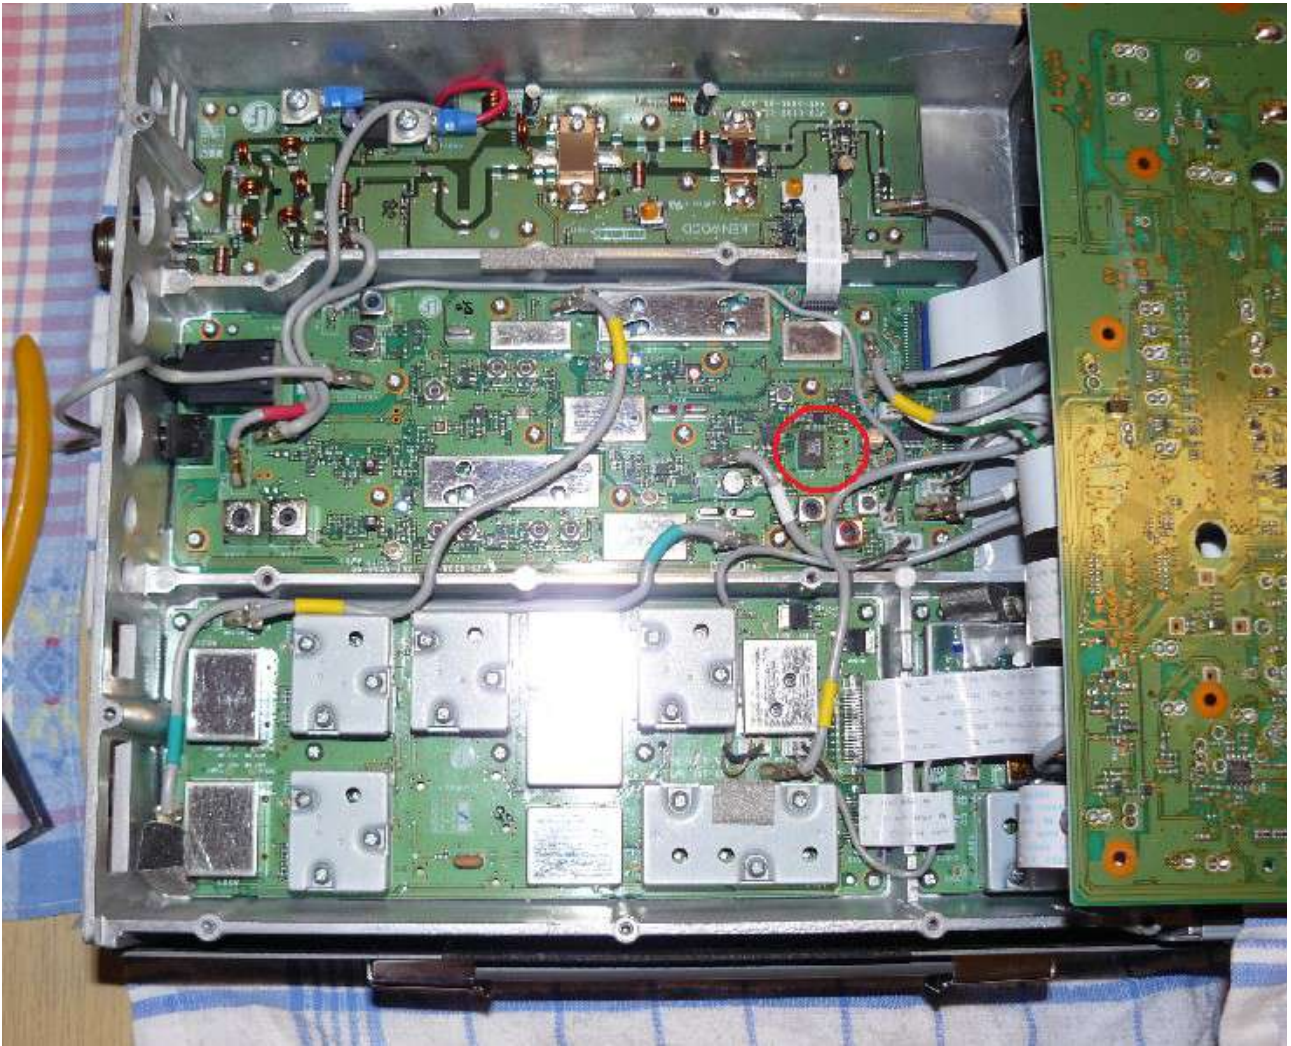
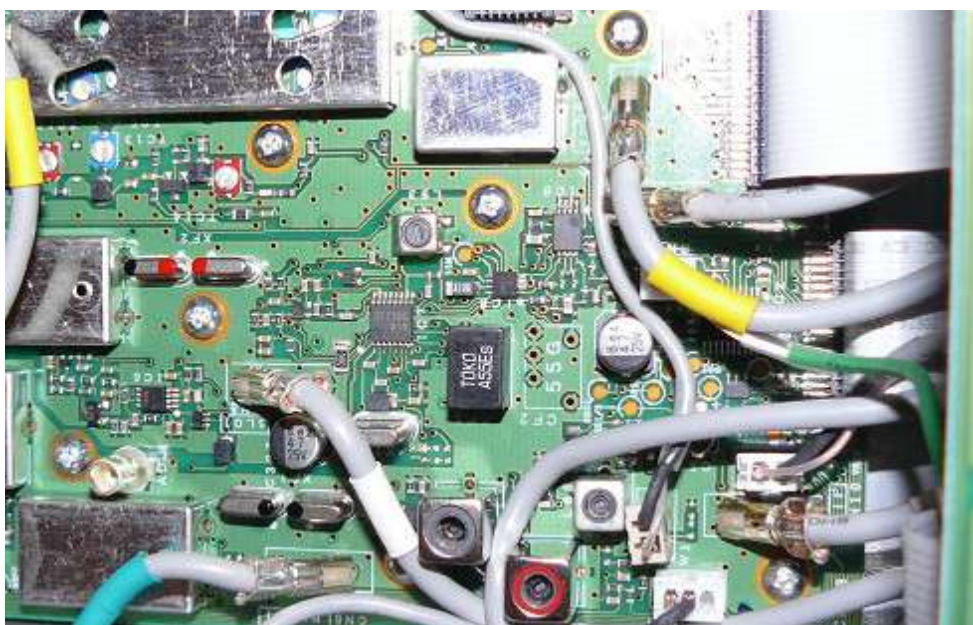
Note this K (USA) version has only the FM-W filter. Replace it with a LTM455EW (15kHz).

You may want to change the SUB receiver ceramic filter(s) as well. Remove the metal shield plate. Locate the Filter on the SUB receiver TX/RX board. This is quite a lot of work as you must remove several cables, then lift out the board and solder out the old filter. Then solder in the new filter(s).

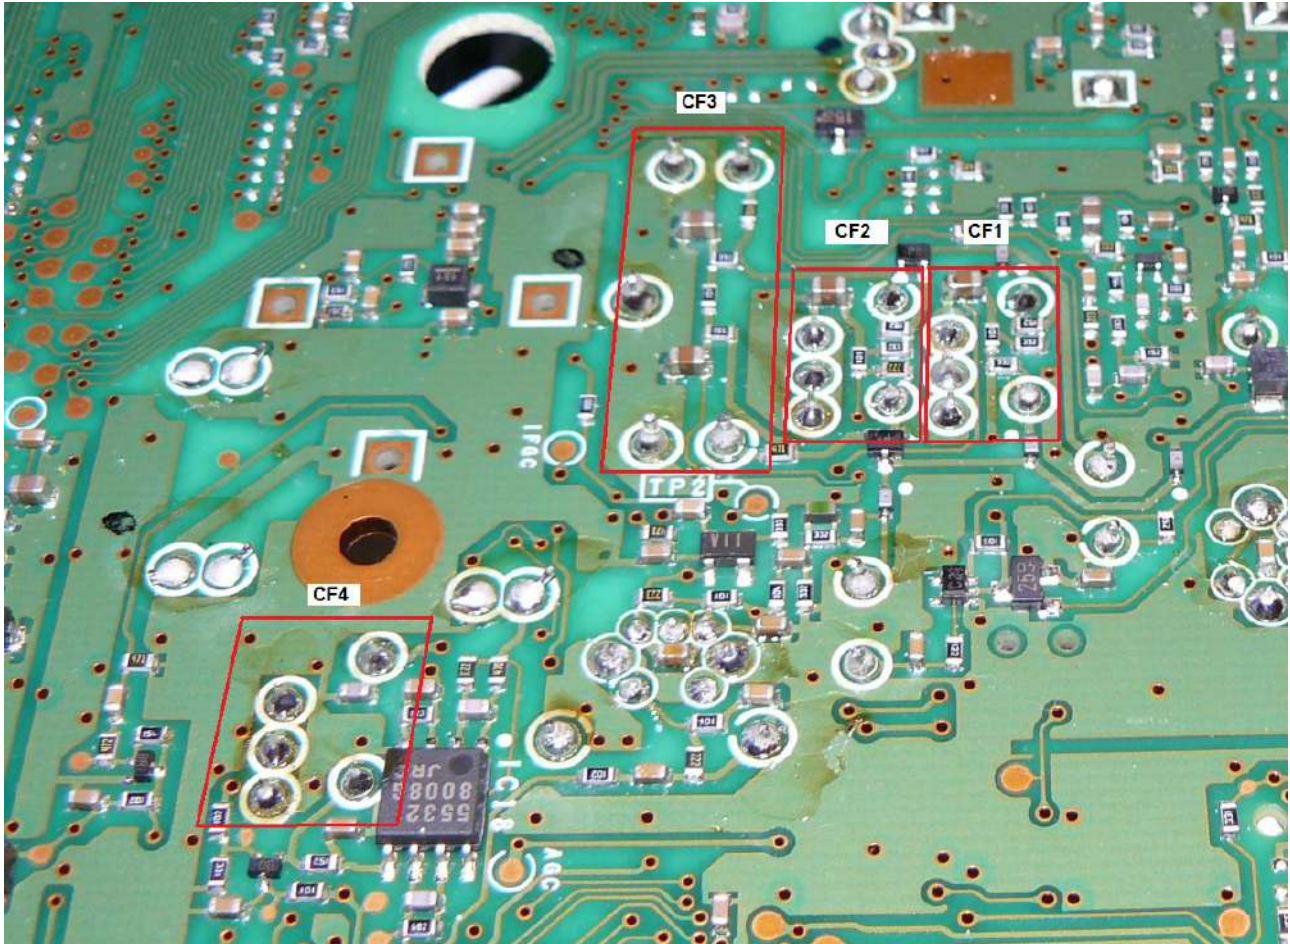
The rear side of the Main TX/RX board do show signs of bad soldering:

The SMD components is of course soldered using a machine, but filters and other large component/parts seems to have been soldered by hand at a later time. There are also some small tin-blobs lying on the board here and there, and on my Radio there was some kind of white powdery substance that was “splashed” out on one corner of the board.

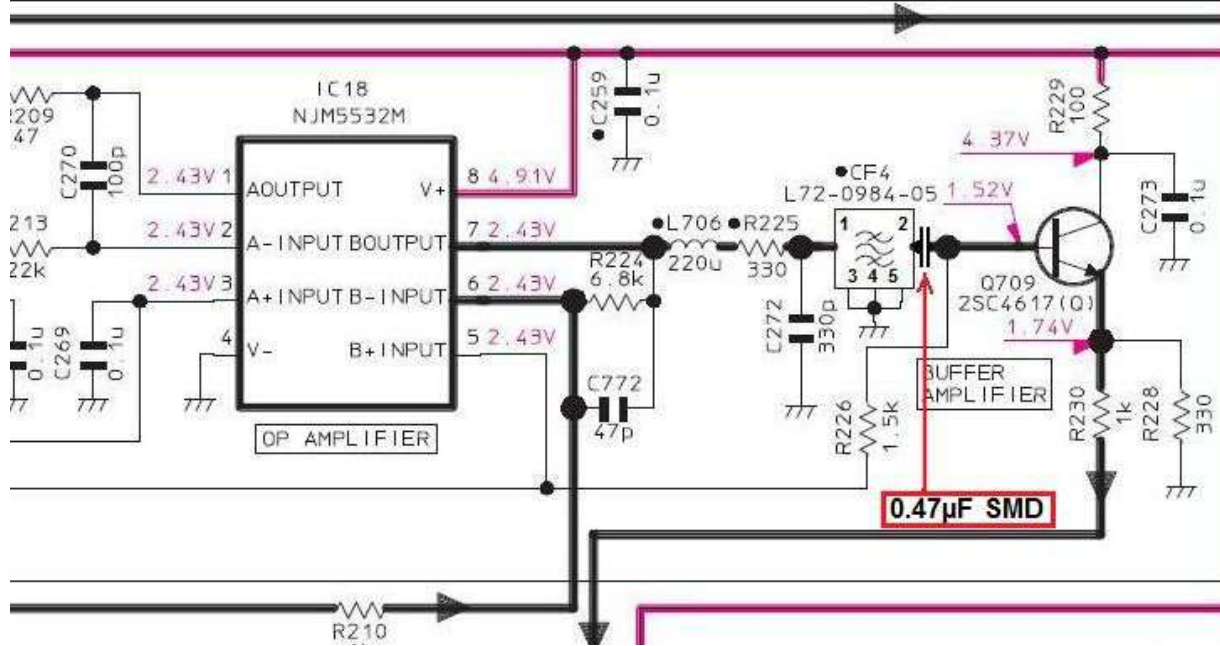
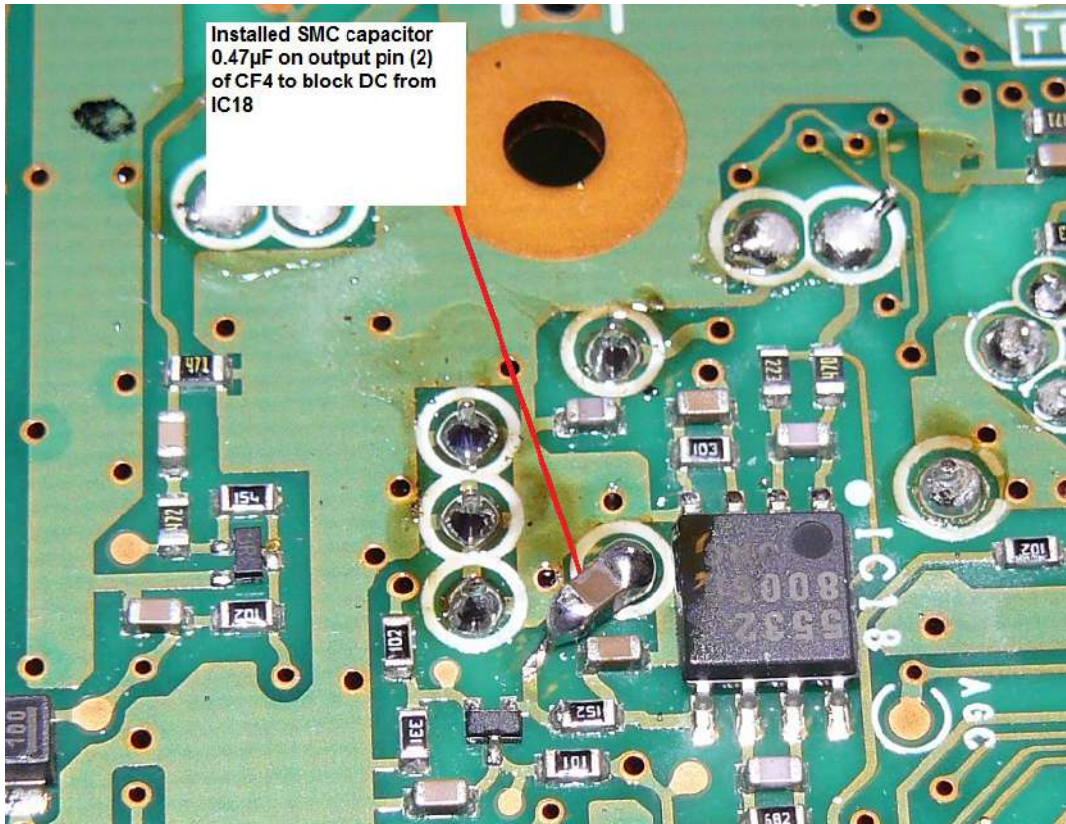
TS-2000 Main TX-RX unit CF4 ceramic filter circuit

The circuit in the service manual show there is no DC blocking capacitor on the output of the CF4 filter. TOKO recommend a DC decoupling capacitor to be installed for safety reasons. The signal goes thru the resistor R226 (1.5k Ω) and directly to pin B+Input on IC. Thus, there is around 1.5V DC on pin 2 on the filter. This must be avoided. So we must install a DC block capacitor on the output of CF4.

Install DC block 0.47µF 0805 X5R capacitor on the output of CF4 to prevent DC from destroying the filter. The X5R has less than 1Ω impedance at 455kHz, so no other impact than DC block will occur in the circuit. You must cut the trace and solder in the SMD capacitor, I found size 0805 to fit nicely. The trace is very small so extreme care must be taken when cutting/soldering.

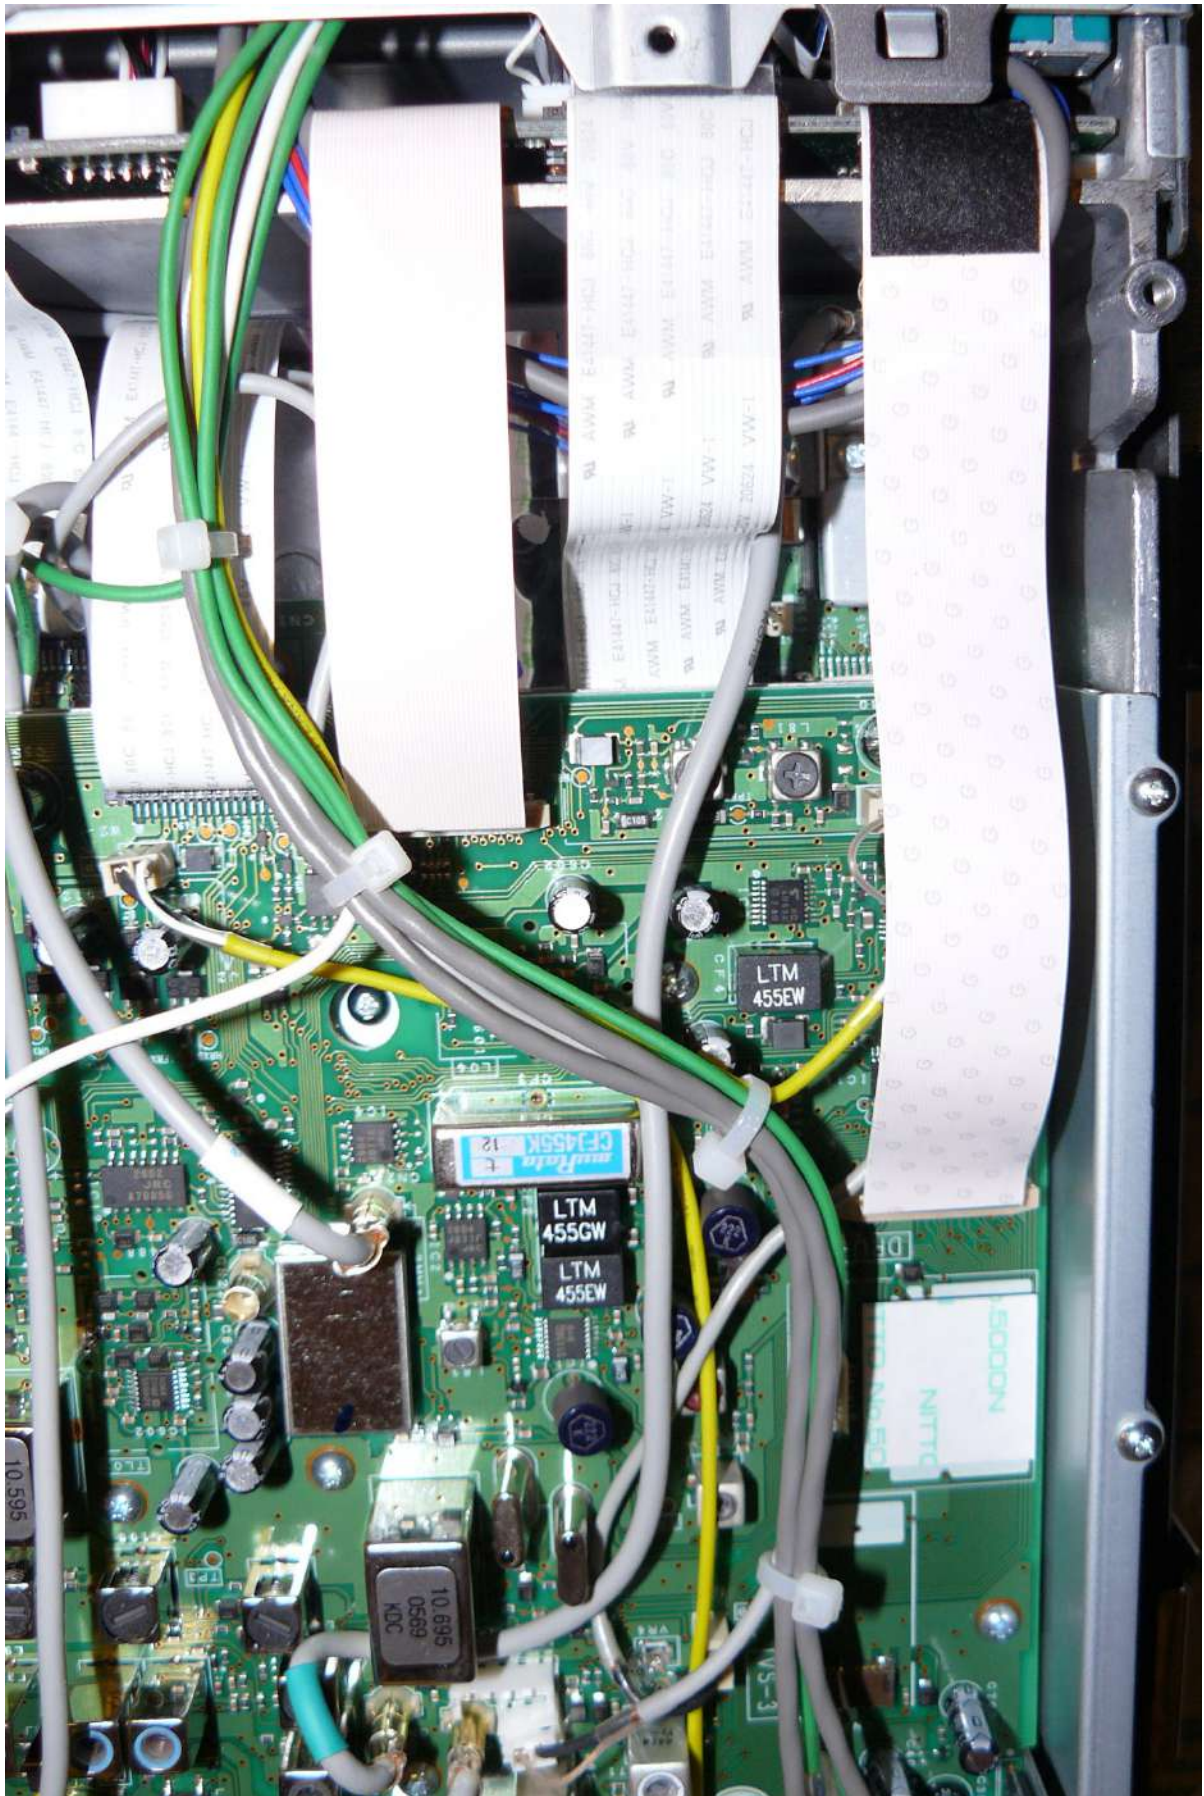
The new filters installed. My TS-2000 now works great, and problem is solved !
