Kenwood TS-2000 receiver crackling noise problem

Ceramic filter failure – how to change the filters

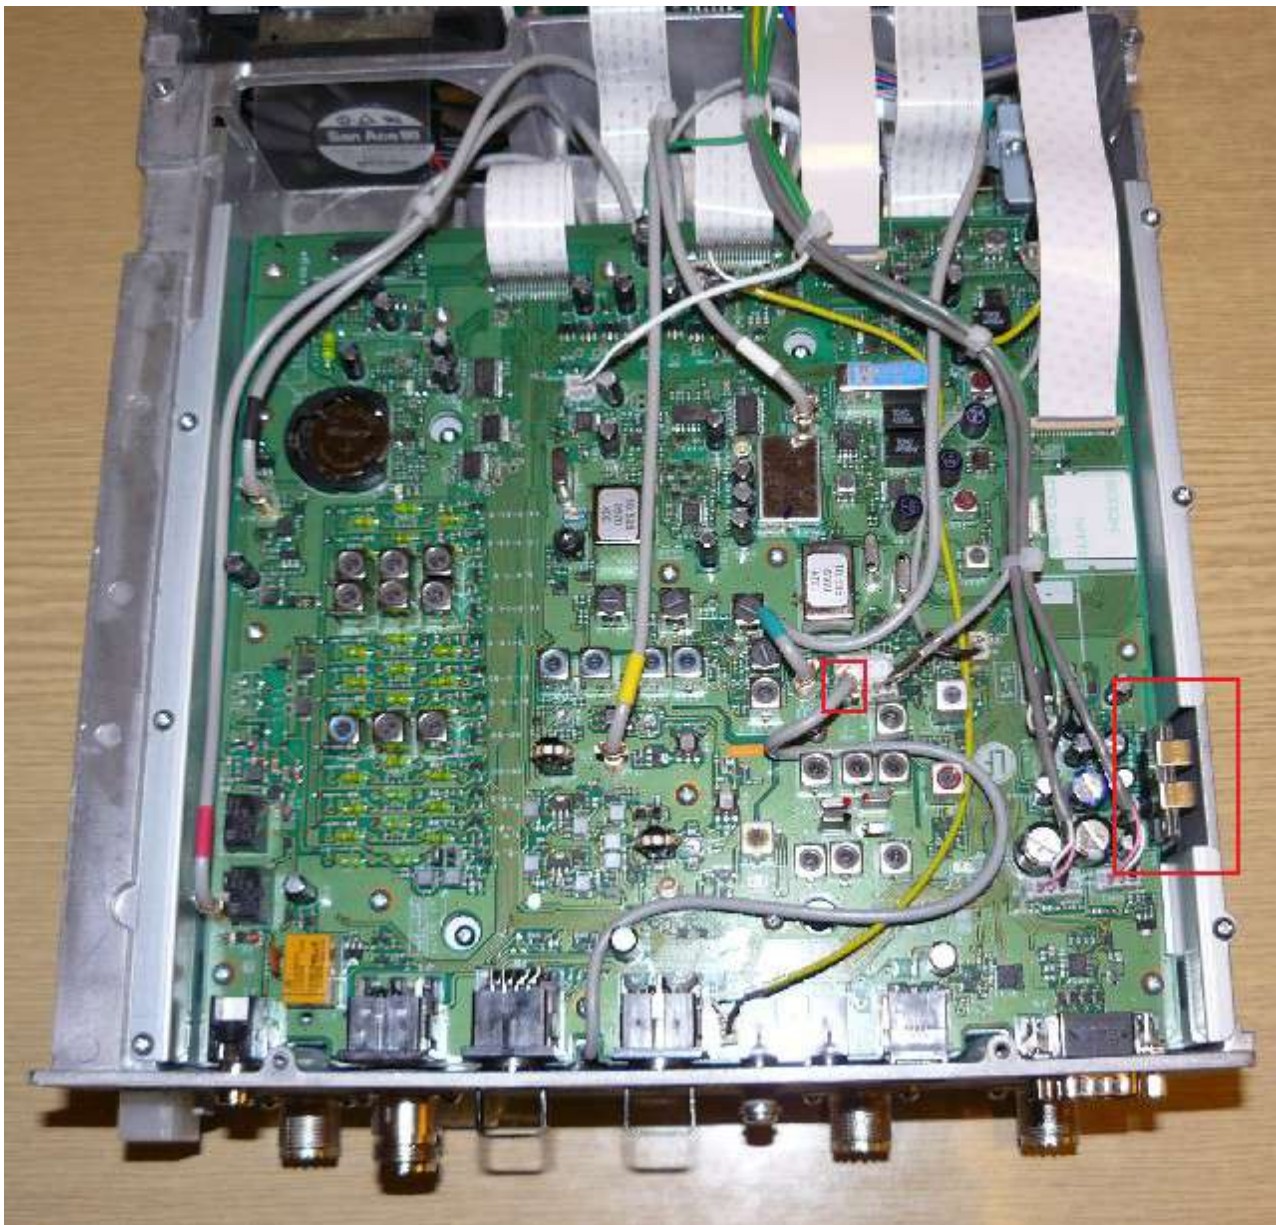
The procedure: Remove the bottom cover. Remove the small steel spring plate that holds the transistors at the side of the radio. Remove only one cable (mini coax) at the rear of the radio.

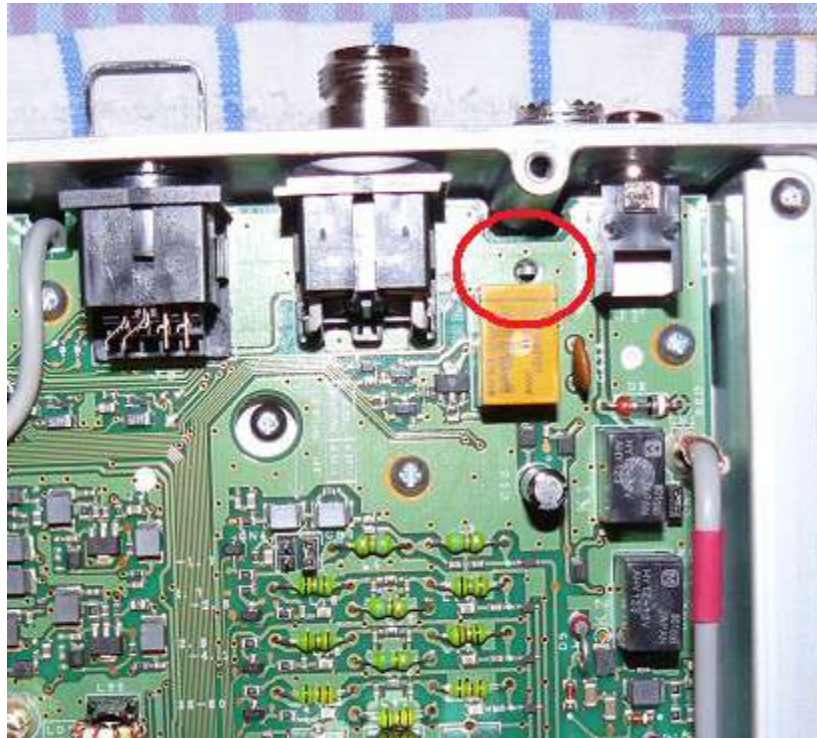
Just lift the board up a bit and move the board a bit towards the front to make all the rear connectors come clear of the aluminum chassis rear end, be aware of the location pin that sticks up in a hole in the board at the rear end. You must lift the board to enable this pin to come clear of the board.

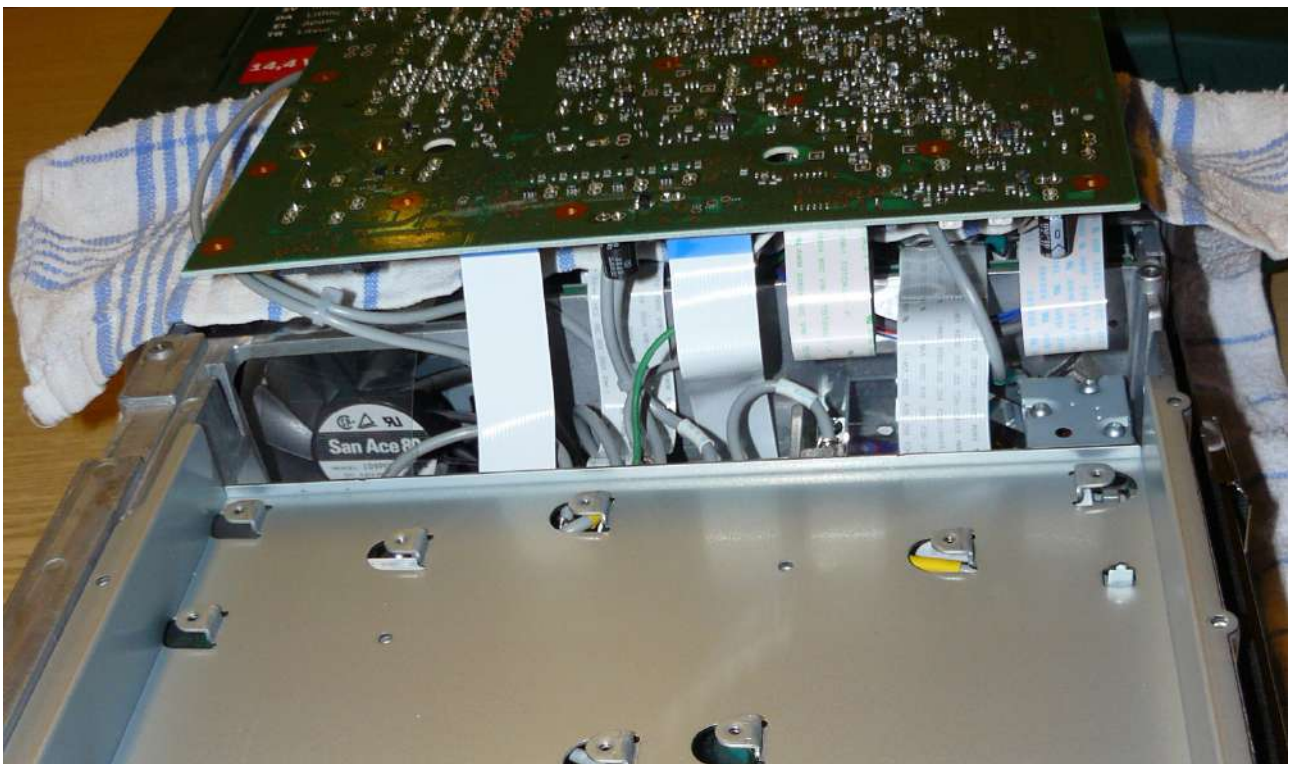
Then flip the board around and lay it with the bottom up on the support to allow soldering on the rear side of the board.
